INSTALLATION RESTORATION PROGRAM
PHASE I: RECORDS SEARCH
KEESLER AFB, MISSISSIPPI

United States Air Force
HQ ATC/DEV
Randolph AFB, Texas
and
AFESC/DEV
Tyndall AFB, Florida

April 1984

ENGINEERING-SCIENCE
57 Executive Park South, N.E.
Suite 590
Atlanta, Georgia 30329

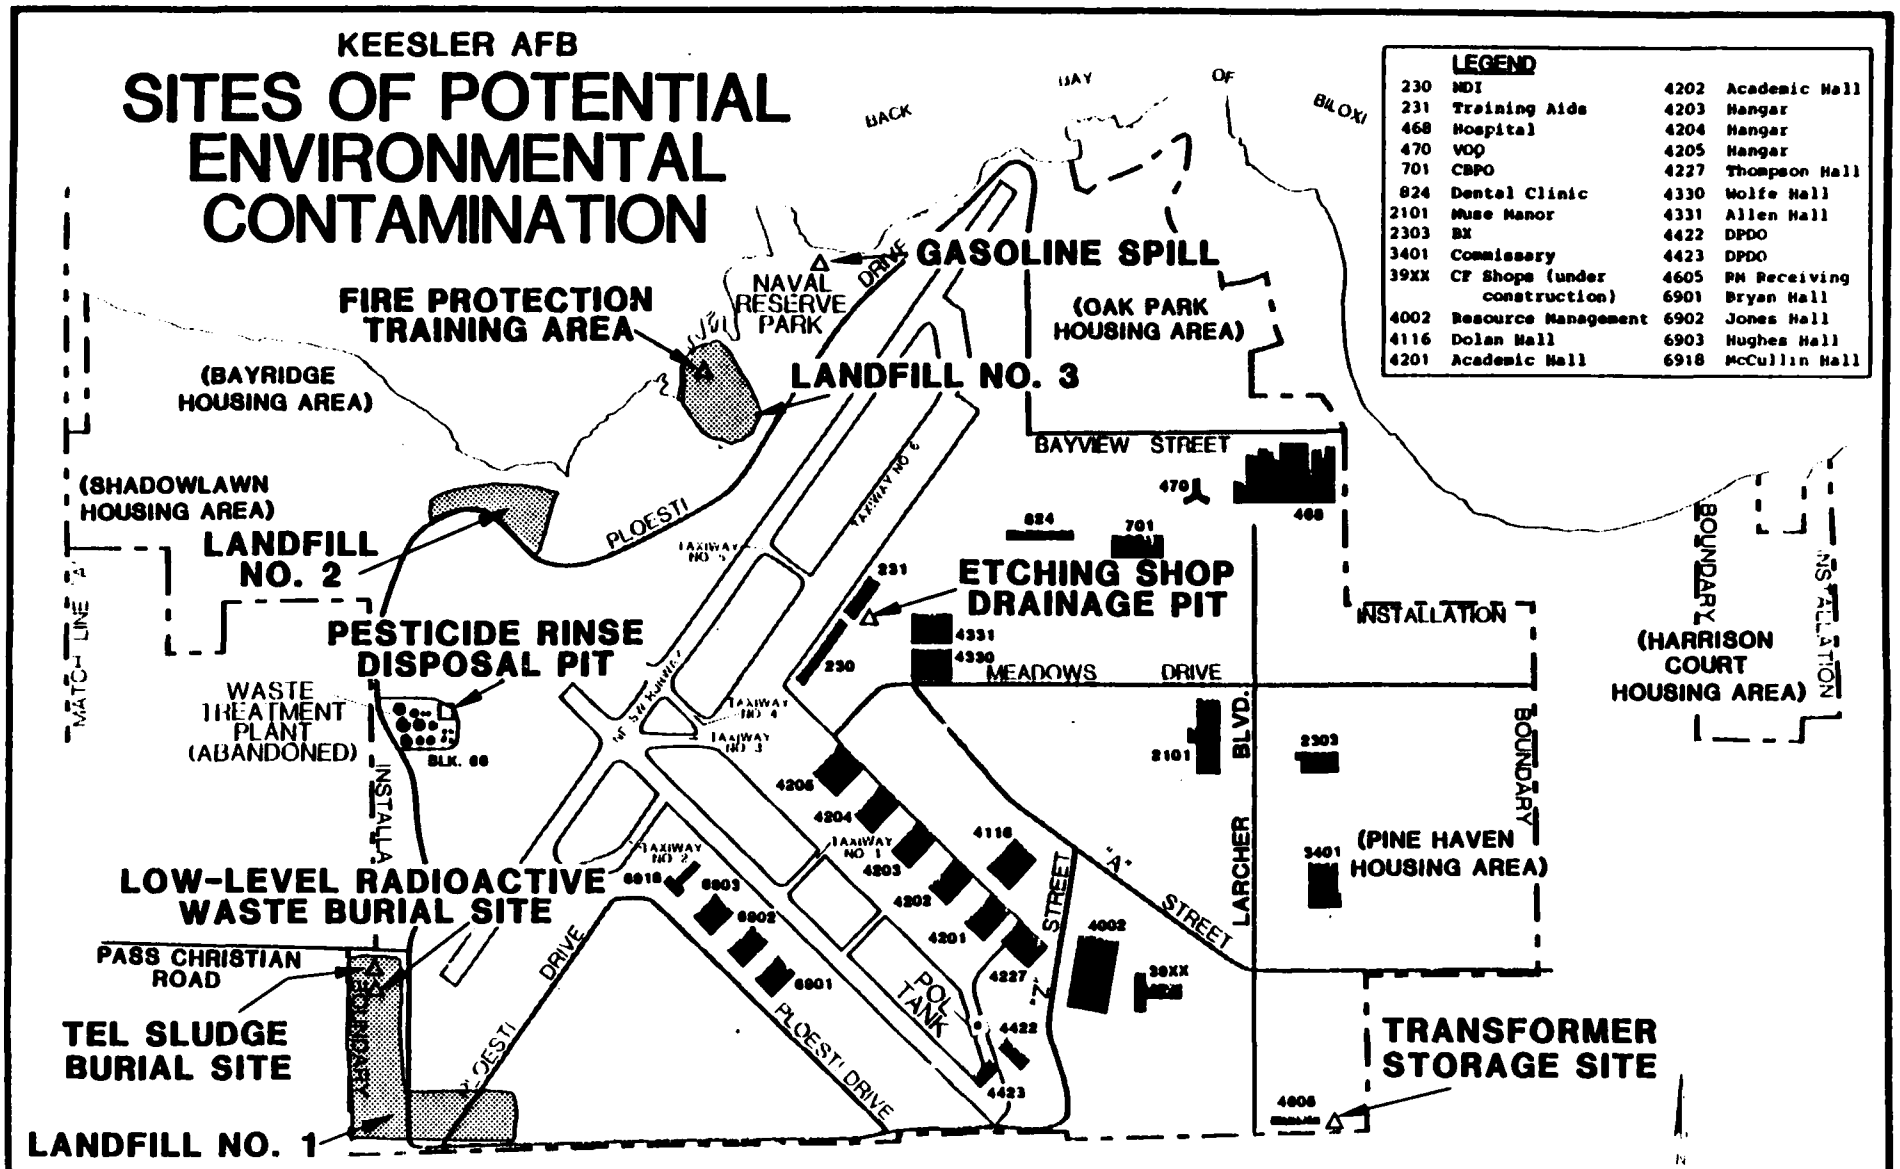
FIGURE 1

SITES OF POTENTIAL ENVIRONMENTAL CONTAMINATION

1) TEL SLUDGE BURIAL SITE IN TRAINING ANNEX NO. 1
2) LANDFILL AT TRAINING ANNEX NO. 1
3) GASOLINE SPILL AT NAVAL RESERVE PARK

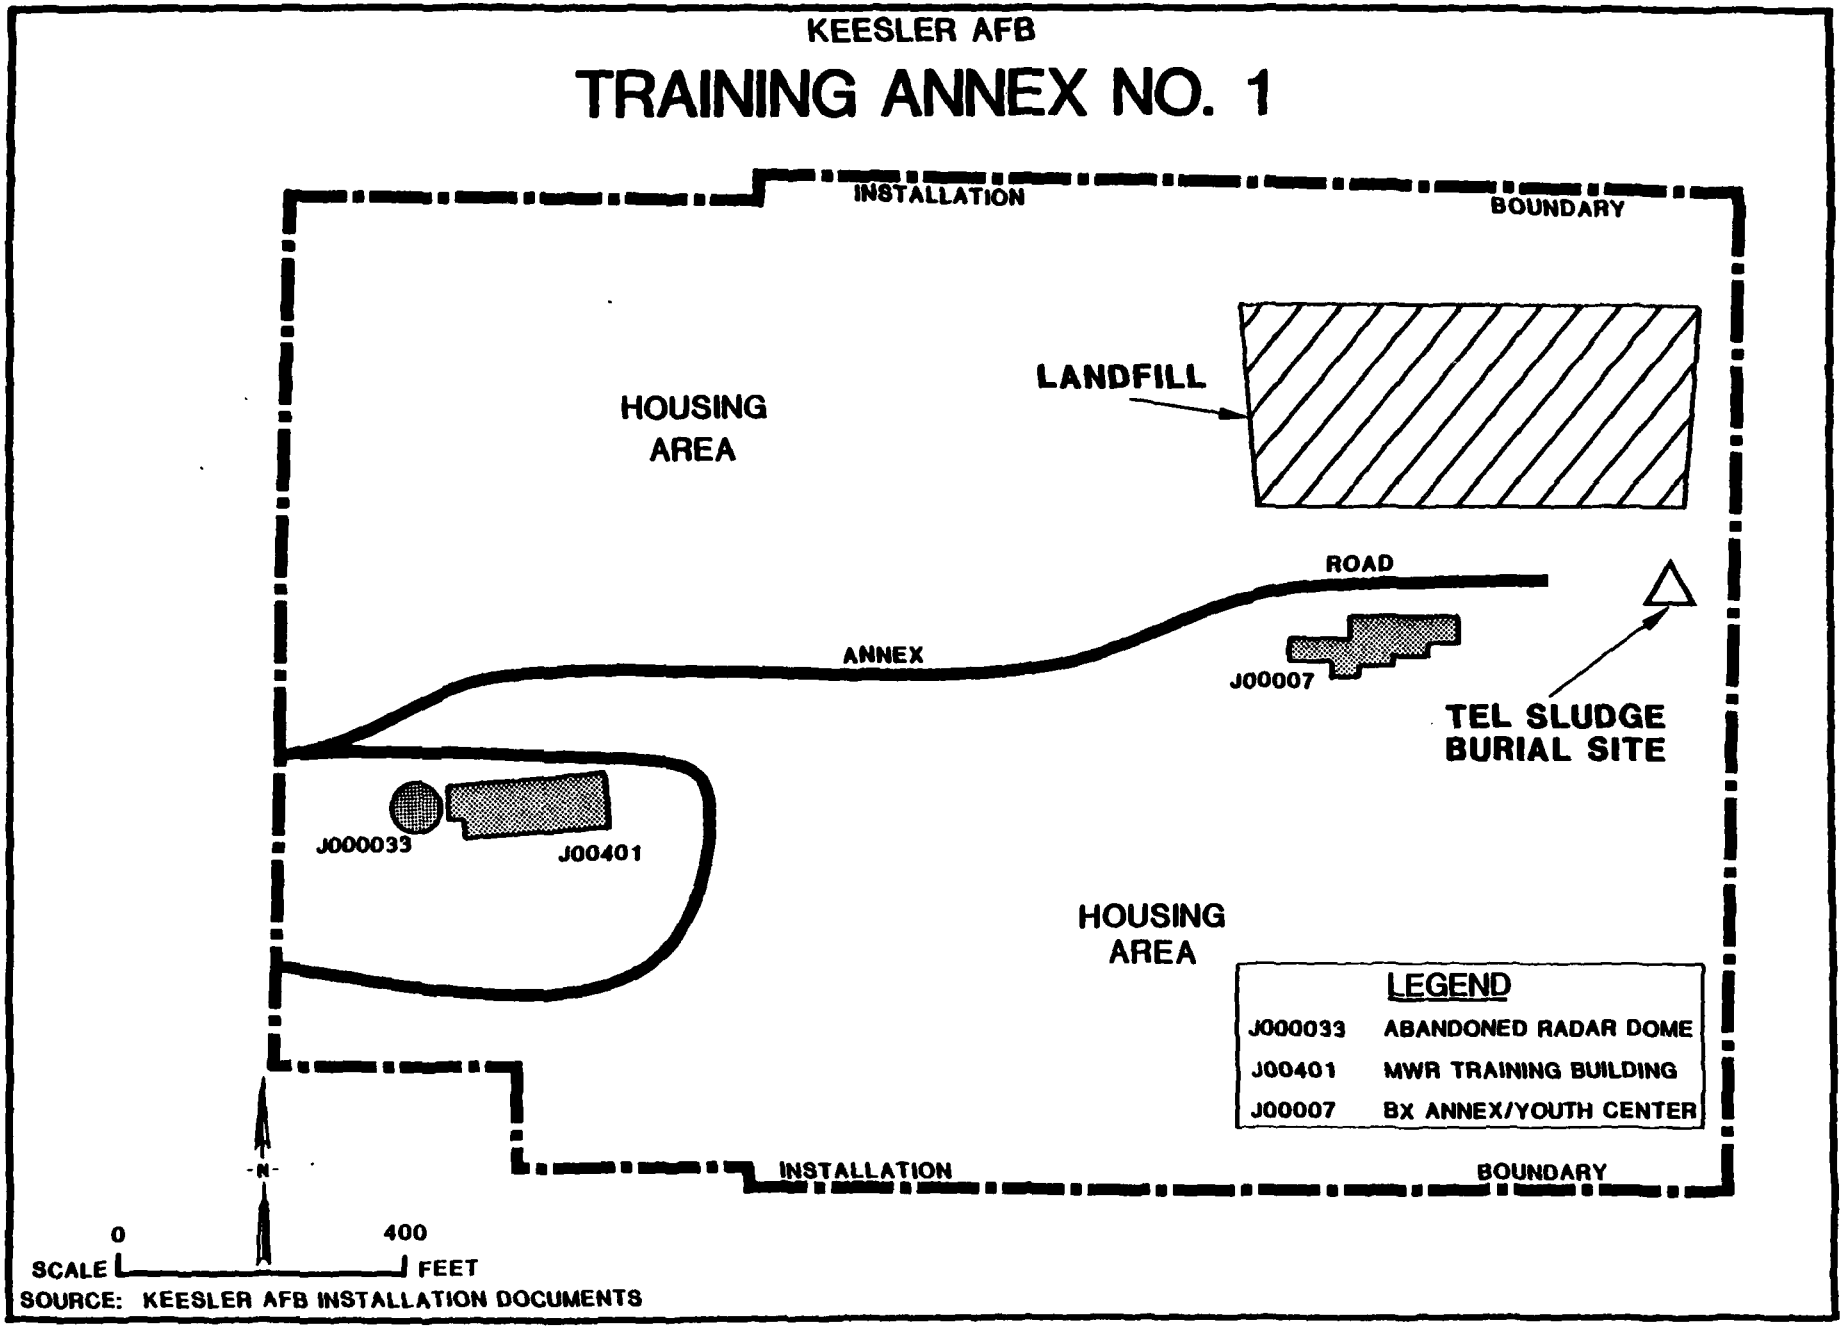
FIGURE 4.1

The Training Annex No. 1 Site (Thrower Park) has been used for waste disposal. A landfill was operated at the northeastern end of the site (see Figure 4.1) from 1968 until 1971. Normal base refuse was disposed and burned regularly during the period of use. No evidence of disposal of hazardous wastes in this landfill was found. The landfill was closed and covered with soil in the early 1970's. At present the site has grass growing on the soil cover. Also disposed at Training Annex No. 1 in about 1970 were three 55-gallon drums of tetraethyl lead (TEL) sludge (see Figure 4.1). These drums were buried at a depth of six feet or less at the eastern end of the site, adjacent to a power pole in the fenced and locked Thrower Park Boat and Trailer Lot.

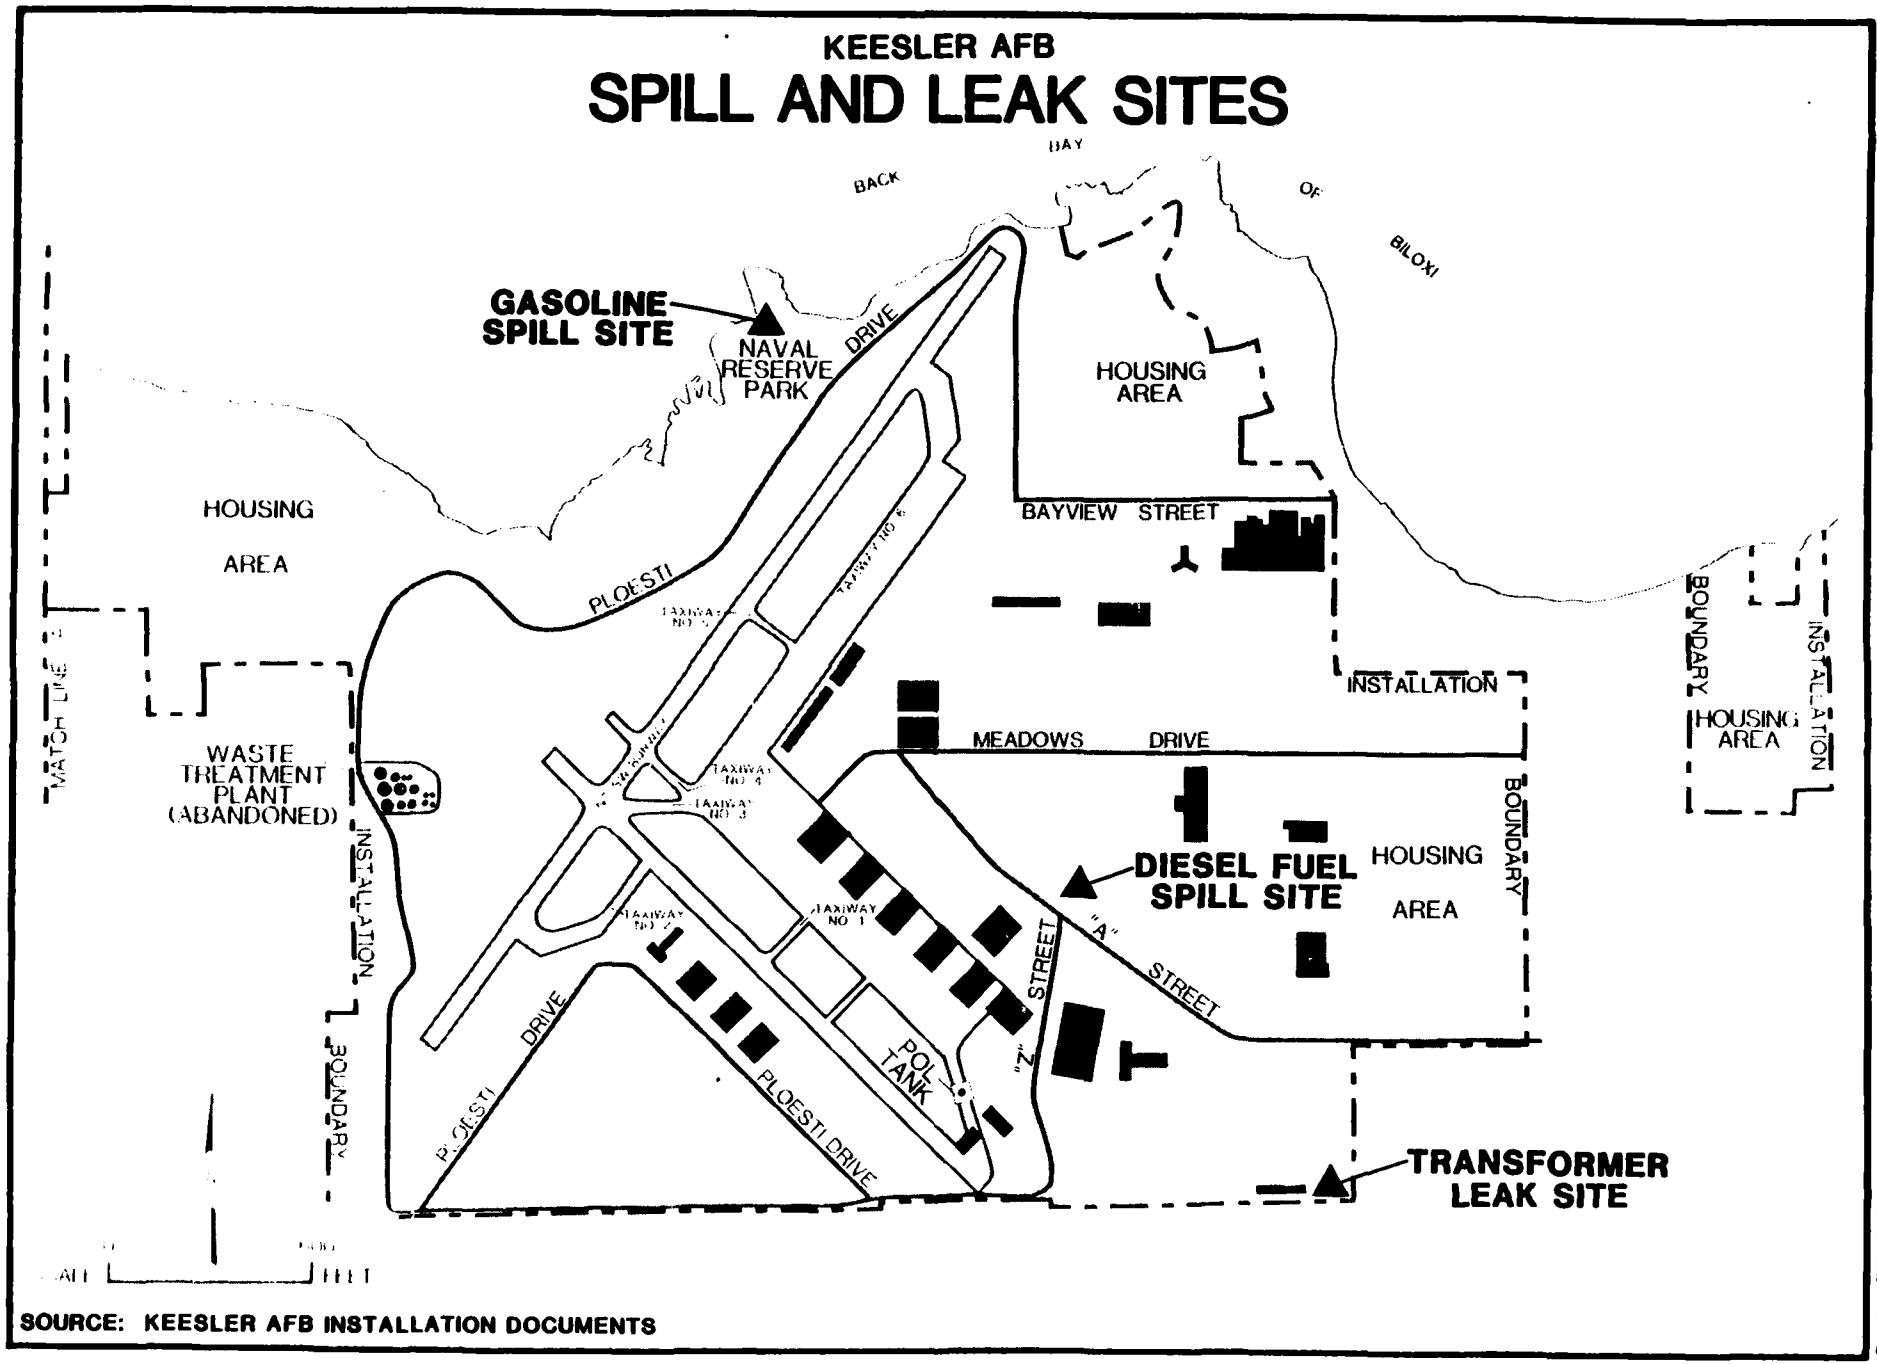
FIGURE 4.3

Two significant fuel spills have occurred (see Figure 4.3). In March 1980, a spill of 570 gallons of diesel fuel occurred near Building 3101. A dam was built to contain the spill, and essentially all the diesel was pumped into 55-gallon drums and removed from the base. The remainder was trapped in a blocked sewer line and removed. In April 1983, a spill of approximately 1,400 gallons of gasoline (leaded) leaked from a newly installed underground tank at the Naval Reserve Park. The spilled gasoline was contained within the gravel surrounding the tank and in nearby soils. A well point system consisting of 10 shallow wells was installed and the majority of the spilled fuel was recovered. Monitoring of the Back Bay waters indicated that no hydrocarbon from this spill was released to the Back Bay. A single well point was left in place to promote evaporation of the spilled fuels. Because of the nature and extent of the reclamation operations, this site is considered to be fully decontaminated.

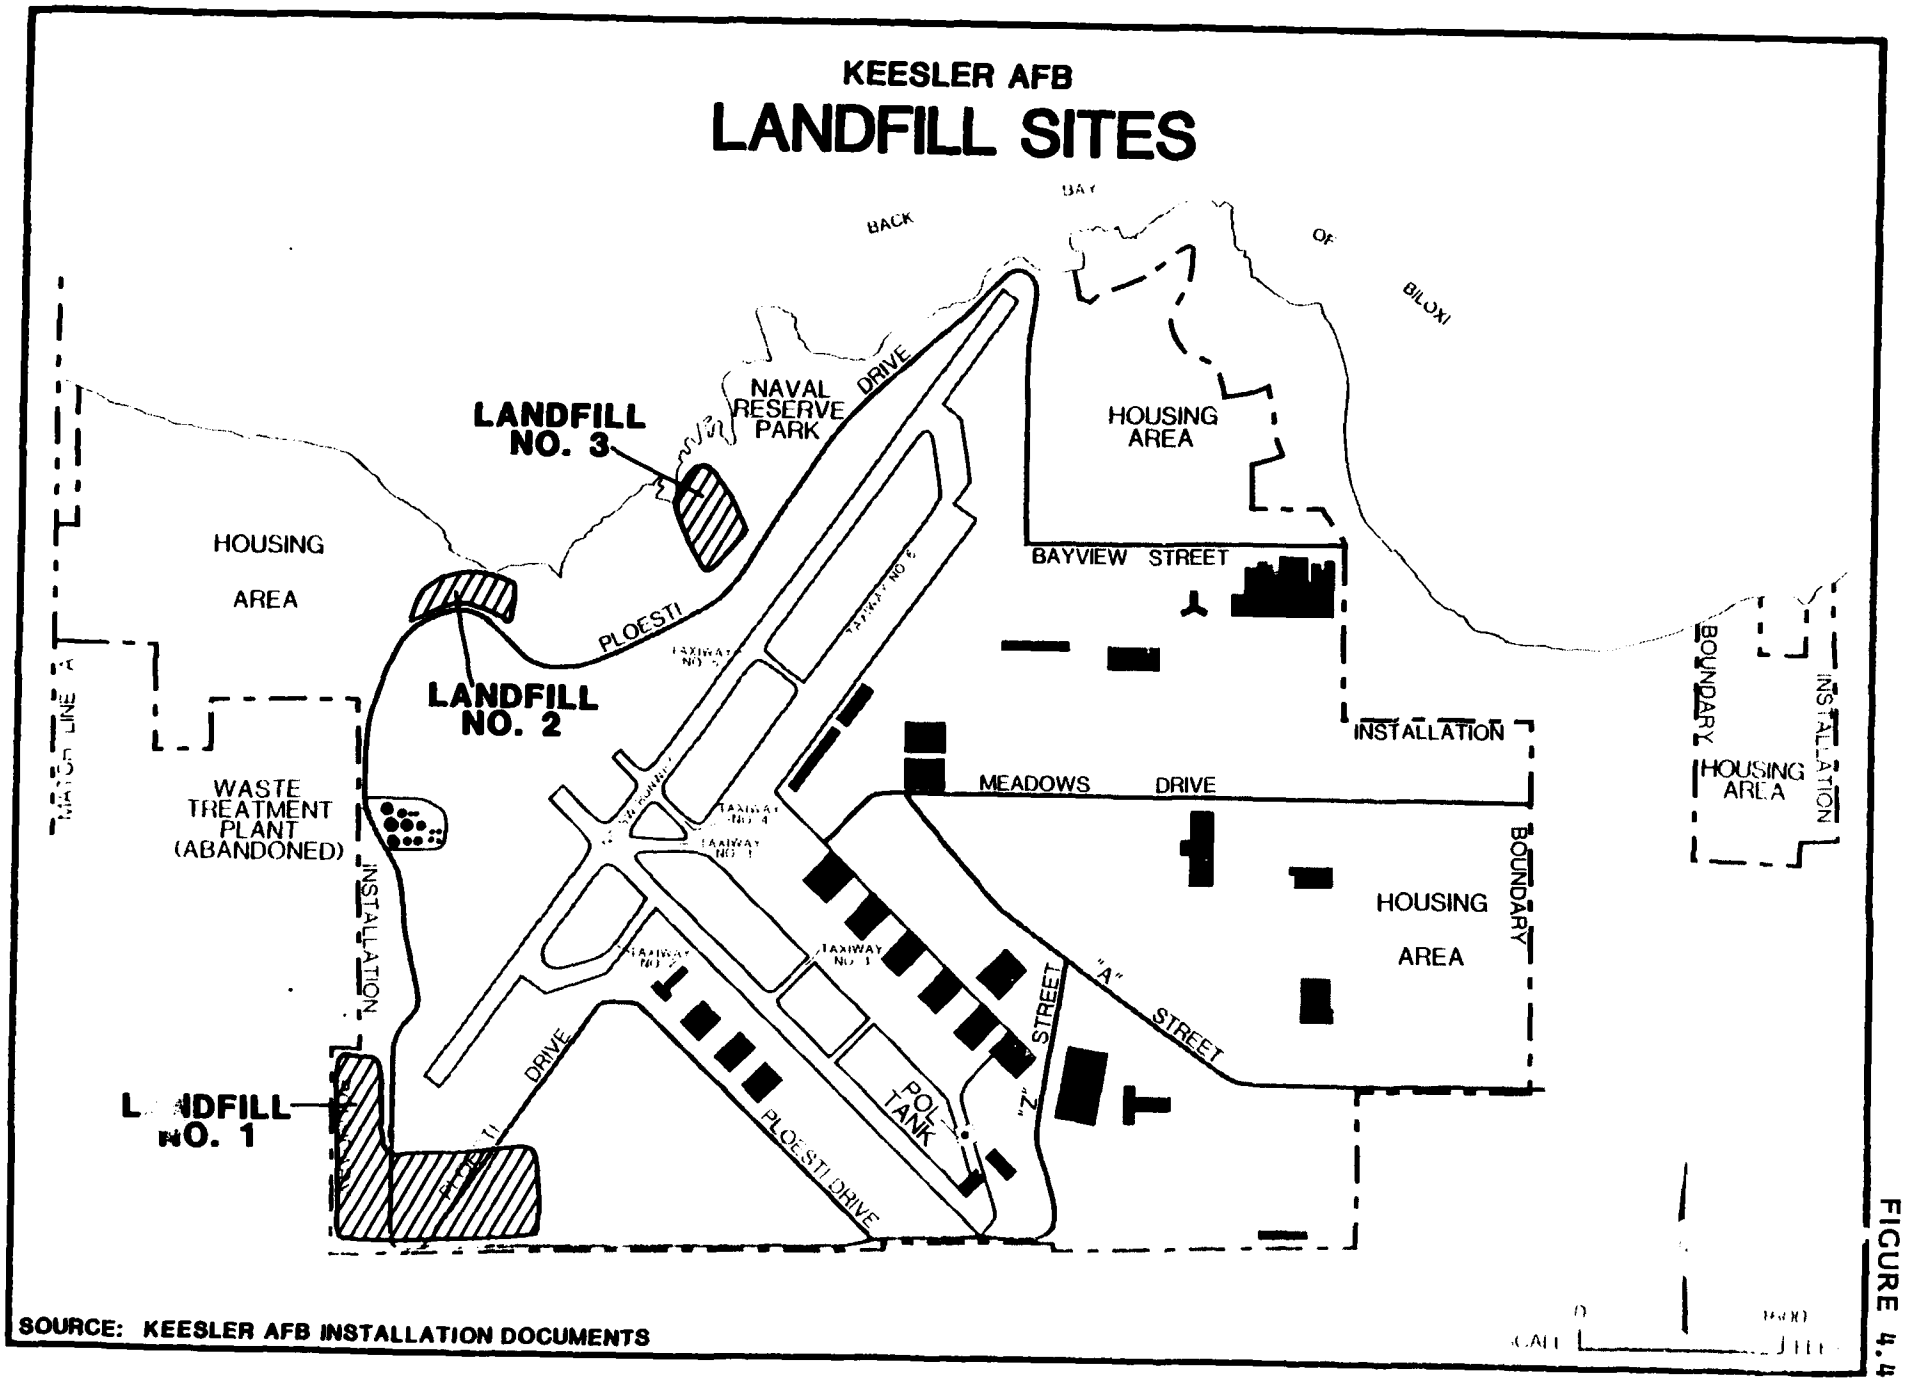
FIGURE 4.4

Landfill No. 1, located at the southwest corner of the base, was used for disposal of base refuse from the time of initial base activity until 1950. Examination of aerial photographs indicates that the western end of the landfill was used during the early 1940's, and the eastern end was used during the middle and late 1940's. The landfill was a trench and fill operation, with trenches normally about 16 feet wide and up to five feet deep. Normal base refuse was disposed of in this landfill; no evidence of hazardous waste disposal at this site was found, although some shop wastes may have been disposed of in the landfill.

The landfill was closed in 1950, the area was filled and leveled, and the base golf course was constructed on the site in 1966.

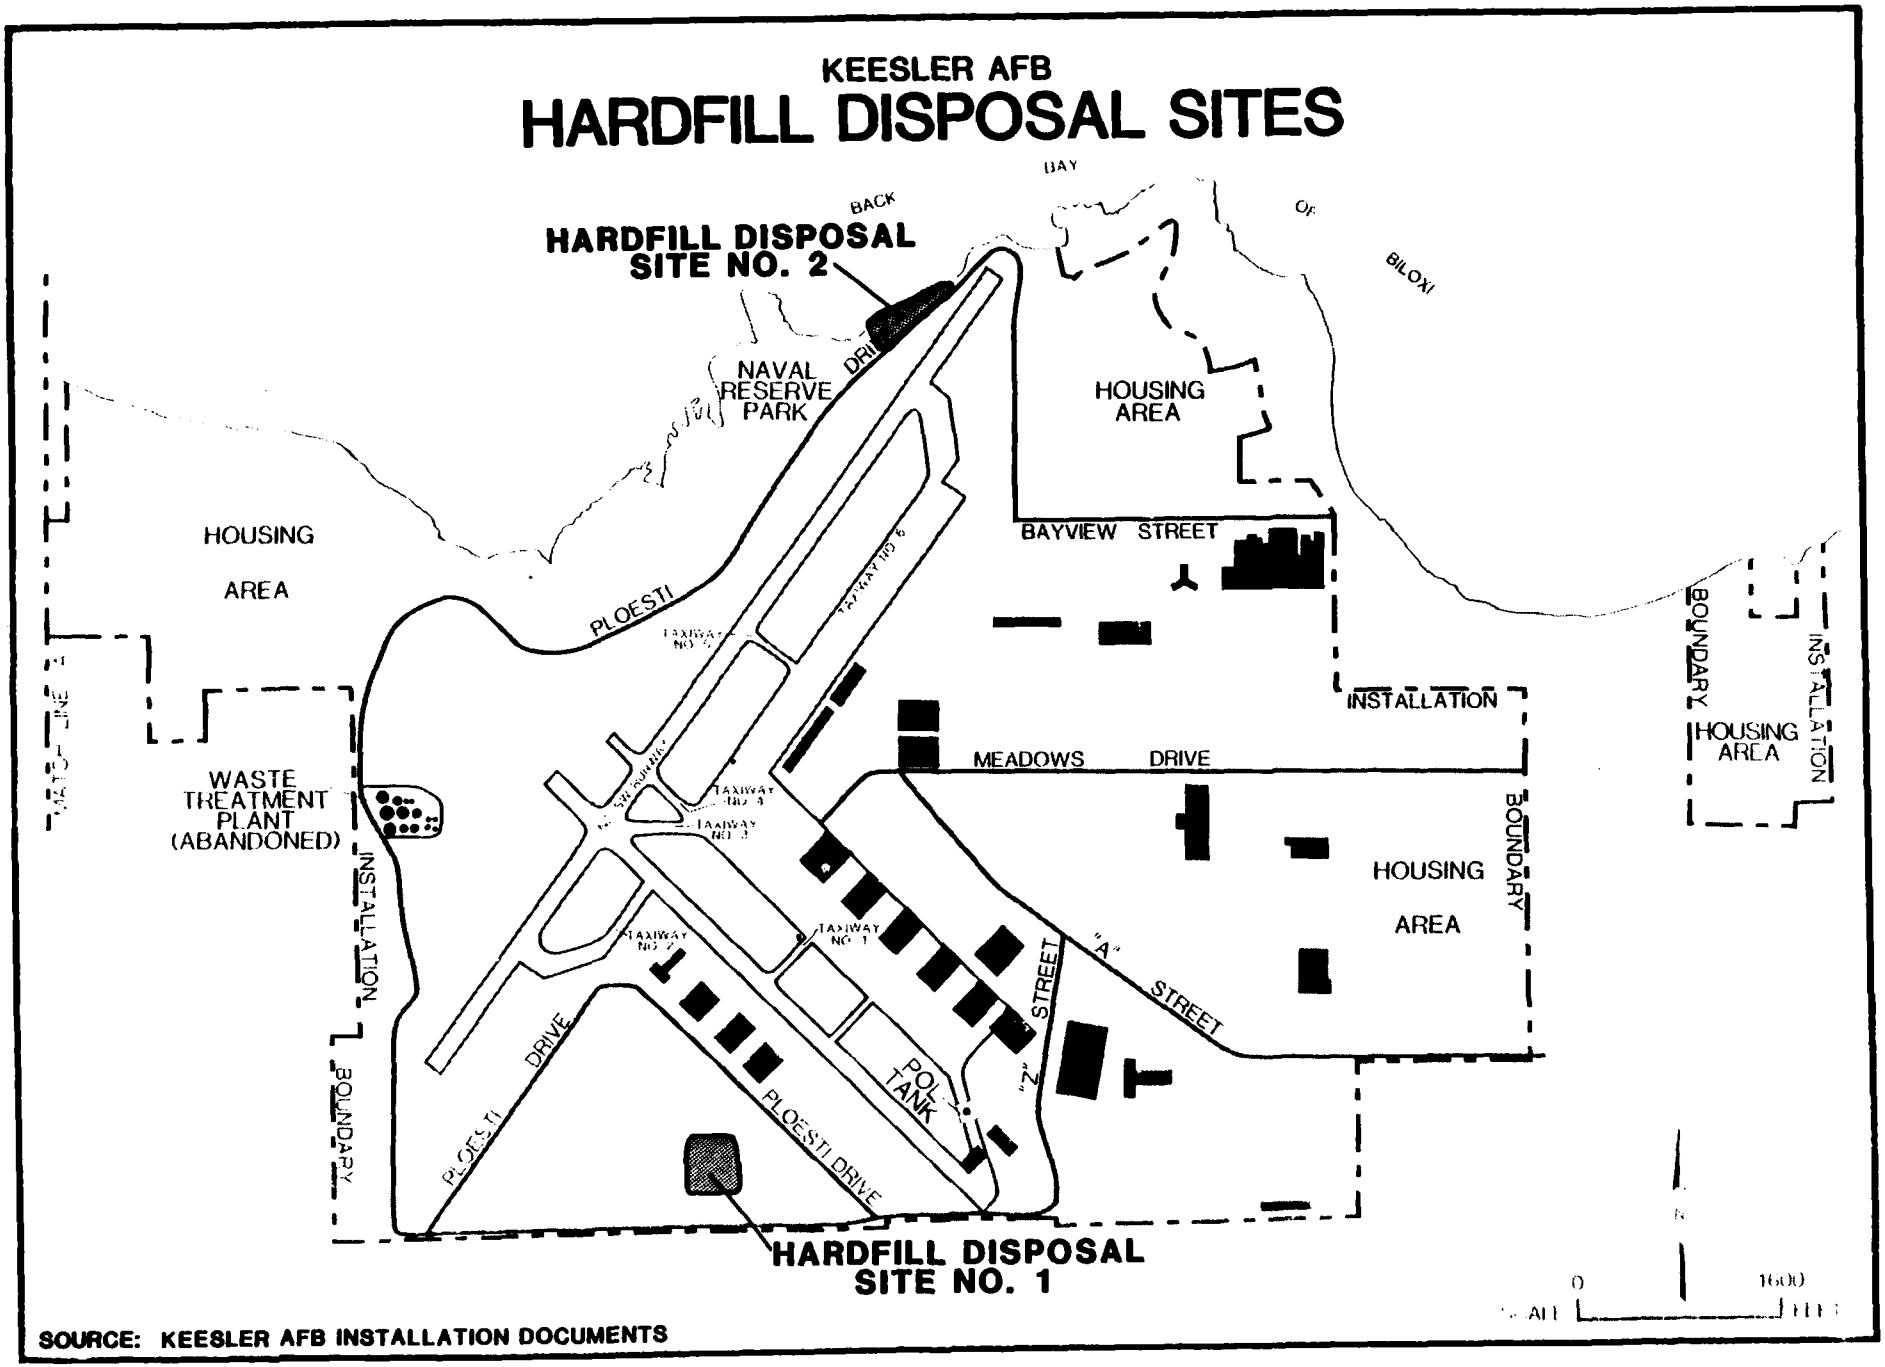
FIGURE 4.5

Two hardfill disposal areas have been identified on Keesler Air Force Base. These areas have been used for disposal of construction rubble and debris; no evidence of disposal of hazardous wastes at either site was found. The locations of these sites are shown in Figure 4.5.

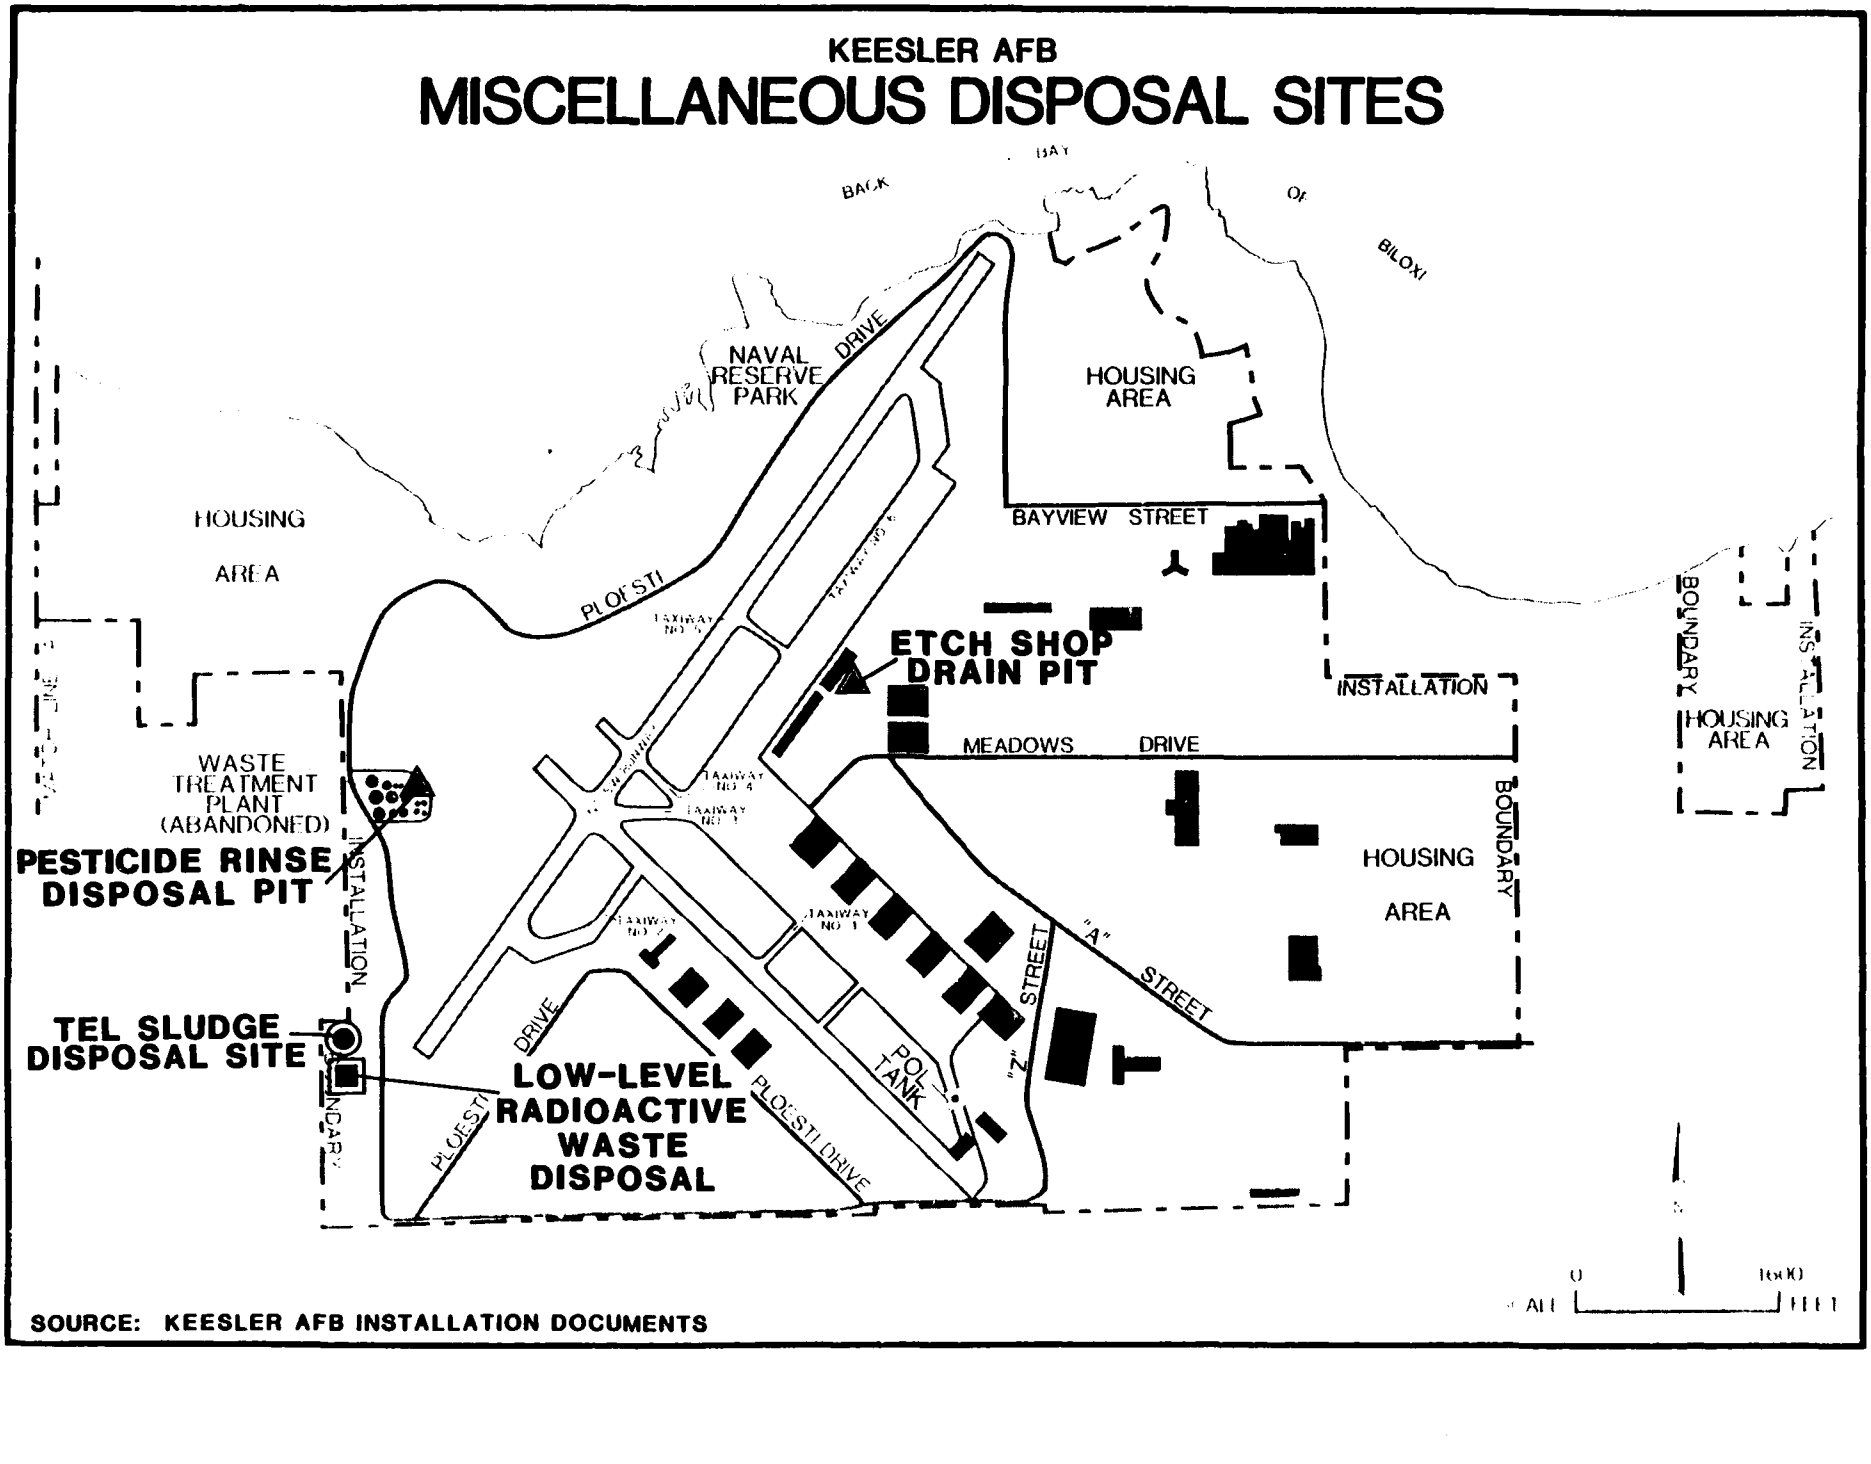
FIGURE 4.6

The second disposal site is in the northern end of the area occupied by Landfill No. 1, presently occupied by the golf course. The location of this site is shown in Figure 4.6. The depth of burial, volume of sludge buried, and types of containers are unknown. It is estimated that the sludge was buried in about 1942. The area is marked by one sign.

A concrete vault was buried at the northern portion of the Landfill No. 1 site in the mid-1950's for the disposal of low-level radioactive wastes (tubes and other low-level sources). Low-level wastes were added to the vault from its installation until about 1960. The site is presently occupied by the base golf course; no fencing or warning signs are present at the site. The location of this site is shown in Figure 4.6.
